SUMMER 2022

Value in Action

Documented Benefits from Hixson's Construction Administration Group

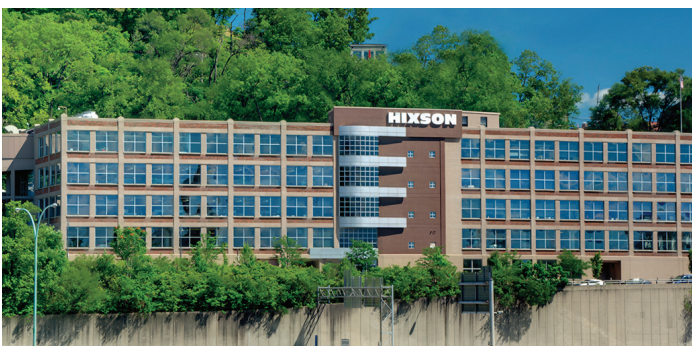
- **Project: Facility Renovation:** *Value - Catching issues before they bcome a problem.*
 - During a routine review, Hixson CA observed that the new steel plate washers were not slotted to allow movement due to the intense climate at the location. If this was not addressed, the repair plate would have caused the concrete at the bolted fasteners to fail.
